FIRE TRAINING AREA NO.2

FT-03

Joint Base Andrews

April 2022

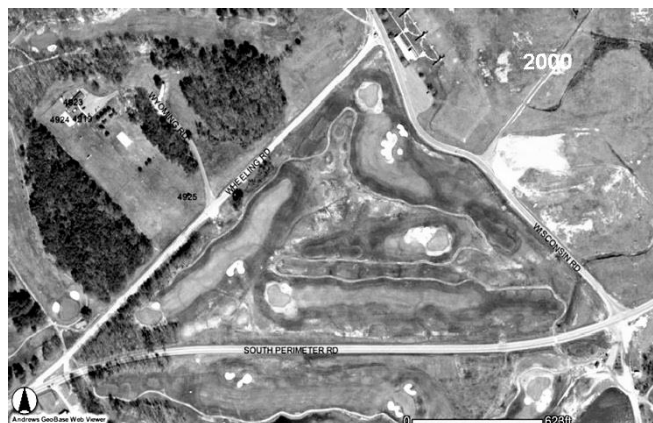
Figure: Designated FT-03 Area

Fire Training Area Number 2 (FT-03) is located on the south-southwest portion of the airfield and was used as a fire training area from 1959 to 1972. During fire training, flammable liquid waste including solvents, paint, oils, and lubricants were released into a bermed area at FT-03 and ignited. Protein foams and chlorobromomethane were used to extinguish the fires. An area adjacent to the bermed area was used to store flammable liquid wastes. Some landfill activity appears to have occurred near this general area in the late 1940s. Unconfirmed reports suggested that a small area adjacent to the bermed areas was used to bury several hundred five-gallon cans of unleaded gasoline. Test pits and an extensive magnetic survey in this area did not locate any of the containers. The 2003 Remedial Investigation (RI) for FT-03 had limited detections of contamination. A golf course now covers FT-03.
