# FORMER FIRE TRUCK MAINTENANCE FACILITY

SS-28 (formerly AOC-32)

Joint Base Andrews January 2018

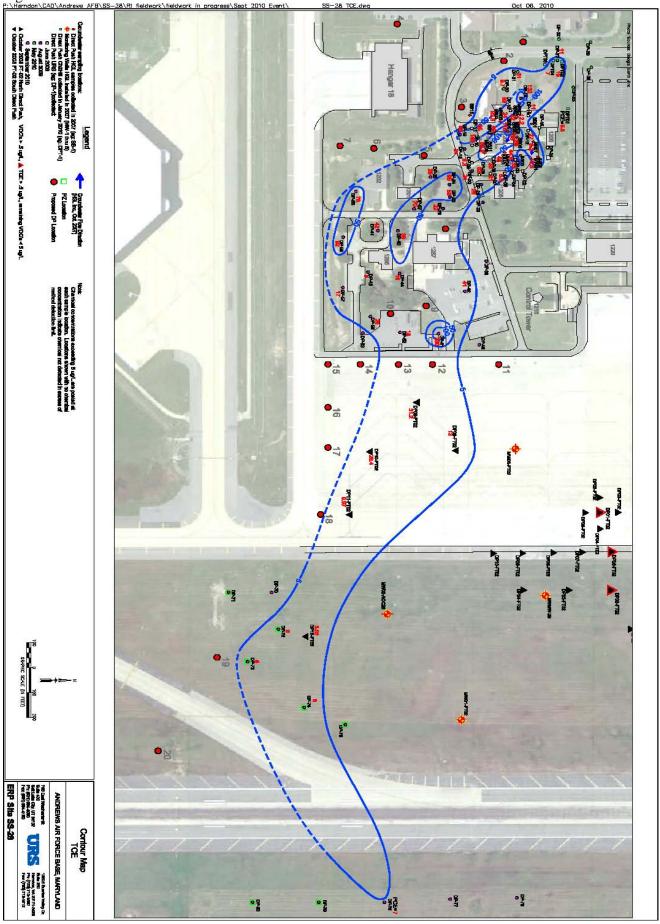
Figure 1: TCE Plume SS-28

Contaminants were detected in groundwater during both the 2006 and 2007 Preliminary Assessment/Site Inspection (PA/SI), but this work did not completely characterize the nature and extent of the SS-28 contaminants. The 2013 Remedial Investigation (RI) identified trichloroethene (TCE), tetrachloroethene (PCE), 1,2-dichlorethane (1,2-DCA), carbon tetrachloride (CTC), chloroform, and benzene in groundwater that require remediation, and detected various other volatile organic compounds (VOCs) from four potential sources areas at SS-28. The resulting contaminated groundwater plumes extend 3700 feet to the southeast and 3,000 feet to the east-southeast from the potential source areas beneath highly secure buildings, a fire station, airfield parking aprons, taxiways, the west flightline, and the grassy airfield. No soil or indoor air contaminants requiring remediation were identified.
